Bio-Rad Laboratories, Inc.

2000 Alfred Nobel Dr.

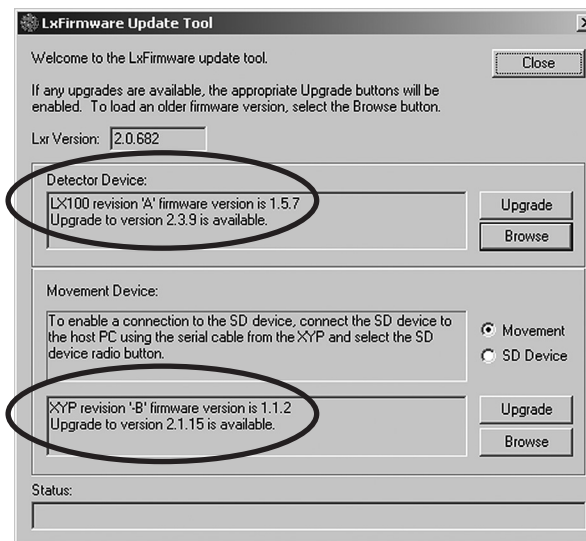
NOTE: If the LxFirmware Update Tool does not detect both devices after 3 minutes, turn the devices off and on. If the devices are still not detected, confirm that the cables are firmly connected to each device, reboot the computer and repeat steps 2 and 3. If the devices are still not detected, contact Bio-Rad Technical Support.

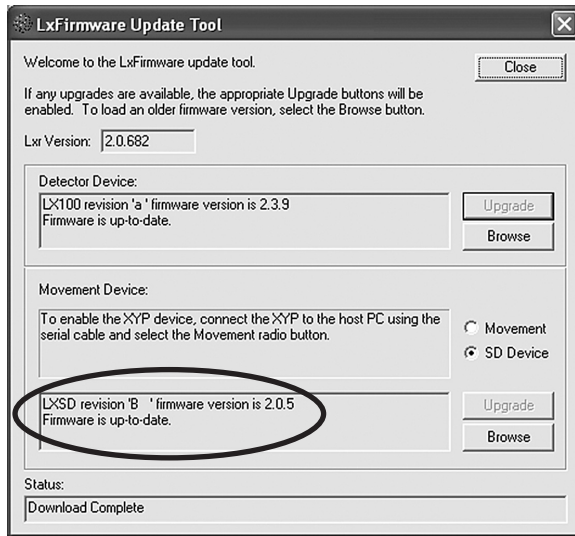
- Record the current firmware version for the SD Device _____. The current firmware version may vary, but the upgrade version for the LXSD Movement Device should always be 2.0.5.
- If the message in the Movement Device box states that the LXSD firmware version is already 2.0.5, skip to step 7. However, if the LXSD firmware version is not 2.0.5 and the message indicates that the upgrade to version 2.0.5 is available, select **Upgrade** and then **Yes** to download version 2.0.5 firmware to the HTF. Select **OK** when the download is complete. The Movement Device box should now indicate that the LXSD firmware version is 2.0.5.
