**Bio-Rad Laboratories, Inc.**

2000 Alfred Nobel Dr.

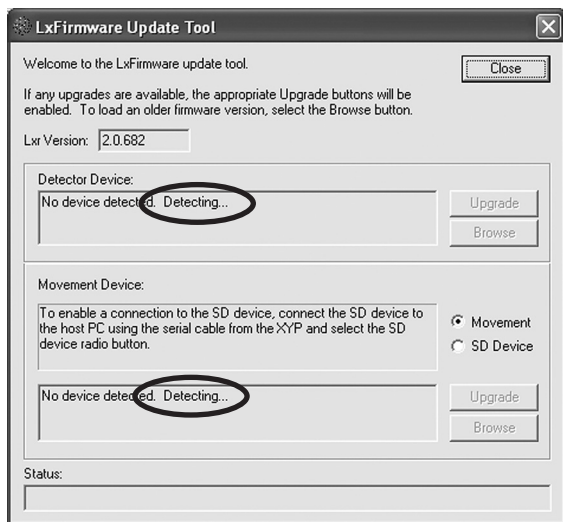
3. Both the Detector Device box (for the array reader) and the Movement Device box (for the microplate platform) will show that the program is detecting the devices (the Movement Device for the HTF/SD Device will be addressed later). It may take up to 3 minutes for both devices to be detected and the screen will appear as shown (some variations of the firmware versions may be observed):

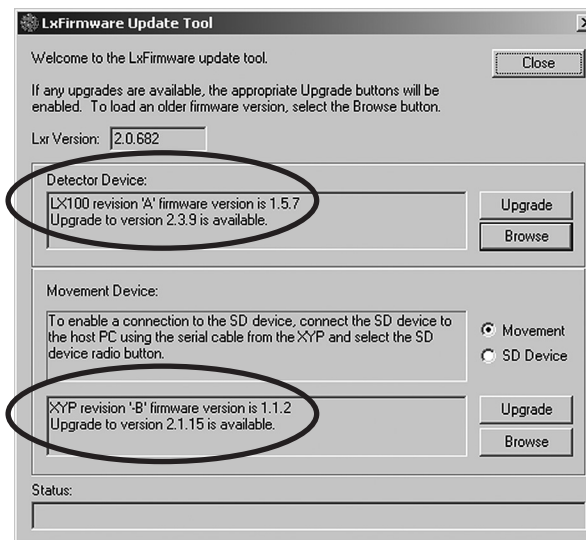
NOTE: If the LxFirmware Update Tool does not detect both devices after 3 minutes, turn the devices off and on. If the devices are still not detected, confirm that the cables are firmly connected to each device, reboot the computer and repeat steps 2 and 3. If the devices are still not detected, contact Bio-Rad Technical Support.

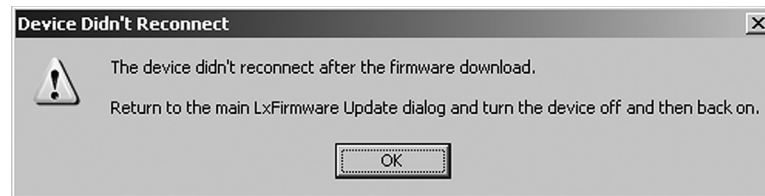
- Close the LxFirmware Update Tool. Power off the array reader and microplate platform prior to proceeding.
- Replace the serial cable that currently connects the array reader to the computer with the new communication cable provided (Catalog # 171-002003). Connect the USB end to the computer and the serial end to the array reader (port P1). Then use the serial cable to connect the microplate platform to COM 1 on the computer (refer to the cable connection diagram in the Appendix).
- Power on the array reader and microplate platform. Restart the LxFirmware Update Tool by going to **Start | All Programs | Luminex | LXR | LX Firmware**. Confirm that the current firmware versions are 2.3.9 for the Detector Device and 2.1.15 for the Movement Device.

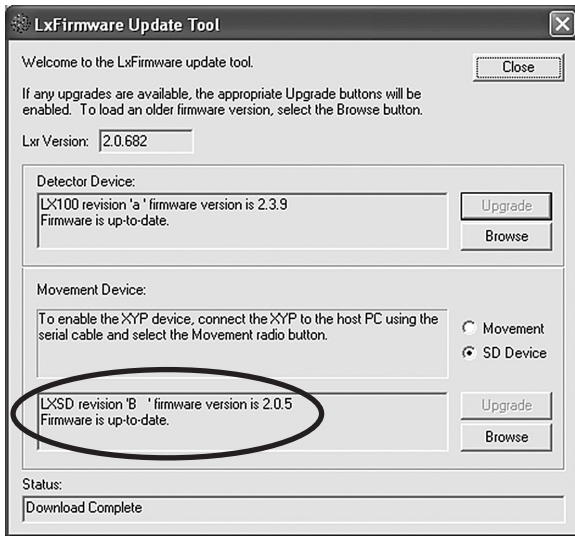
- Record the current firmware version for the SD Device \_\_\_\_\_. The current firmware version may vary, but the upgrade version for the LXSD Movement Device should always be 2.0.5.
- If the message in the Movement Device box states that the LXSD firmware version is already 2.0.5, skip to step 7. However, if the LXSD firmware version is not 2.0.5 and the message indicates that the upgrade to version 2.0.5 is available, select **Upgrade** and then **Yes** to download version 2.0.5 firmware to the HTF. Select **OK** when the download is complete. The Movement Device box should now indicate that the LXSD firmware version is 2.0.5.
